HITCHCOCK'S MOTORCYCLES LTD
OLDWICH LANE WEST
CHADWICK END
SOLIHULL
B93 0EY ENGLAND

BULLET OIL PUMP SPINDLE

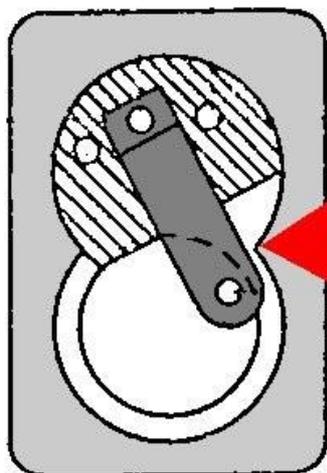
**Check for
clearance
between
plunger
and cover**

resistance. Follow this by fitting the return pump and plunger, (this is the bigger of the two pumps in the front of the timing cover). Without fitting the oil pump cover rotate the spindle and make sure that the oil pump plunger does not foul on the pump housing as shown in the diagram. Once this has been checked assemble the complete pump assy with spring, end pad, gasket and cover, tighten the 4 screws and then check the oil pump spindle rotates the full 360 degree with light thumb pressure. (At this stage you would expect a bit more resistance, but still light thumb pressure). If the spindle is hard to turn, the most likely cause is too much end pressure from the oil pump spring. Since 2001, Enfields

have fitted a lighter spring, part number 144134, if you have an earlier model replace the spring with this new part. Alternatively re-fit the pump cover with two gaskets and check the rotation of the spindle again which should now be ok. Now repeat the same steps with the feed pump, expect a bit more resistance with both pumps fitted, but this should still be able to rotate with reasonably light thumb pressure.

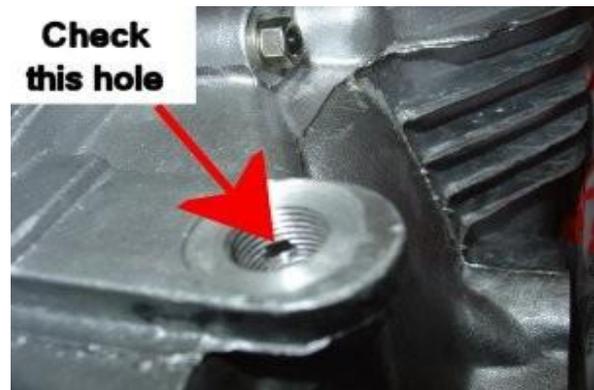
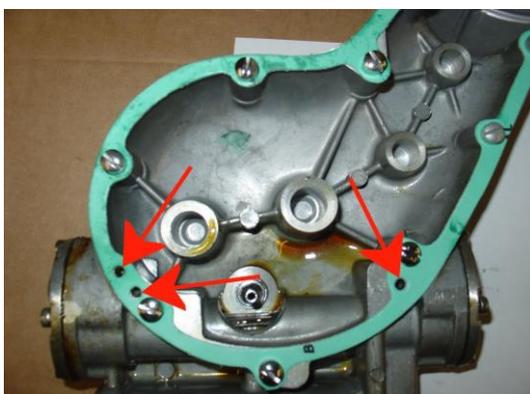
DRAIN PLUG/FILTER: Oil is taken, by means of the return pump, from the sump (where the crankshaft lives) through internal oil drilling's in the crankcase to the front drain plug/filter. Sometimes the threaded part of this plug can restrict the oil drilling by screwing in too far. This can be down to machining tolerances or a washer fitted that is too thin. By careful measurements this can be checked and a thicker or extra washer fitted if required.

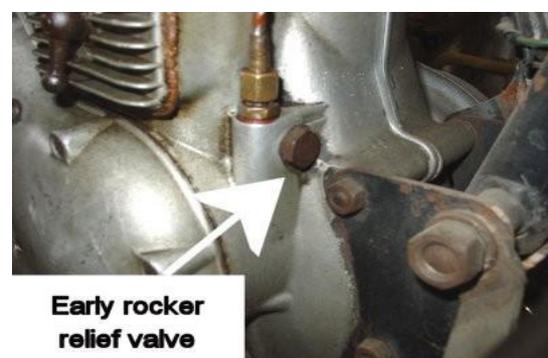
ROCKER FEED PIPE AND ROCKERS: Check that the oil flow through the rocker pipe is good. These can be partially blocked by excess solder during manufacture and damage from the outside. Again this can restrict the flow causing extra work for the whole oil pump assembly. On the Redditch models, for most years, there was a relief valve in the crankcase just below the rocker feed pipe. This continued on the

removed and has not been fitted since. A mistake in my opinion! This valve should relieve at approximately 30psi but were never very accurate. If you are one of the lucky ones and have this relief valve fitted, then check that it is working correctly. An airline with pressure gauge can be used for this. Also check that the rocker feed pipe banjo bolts are clear and in good condition.

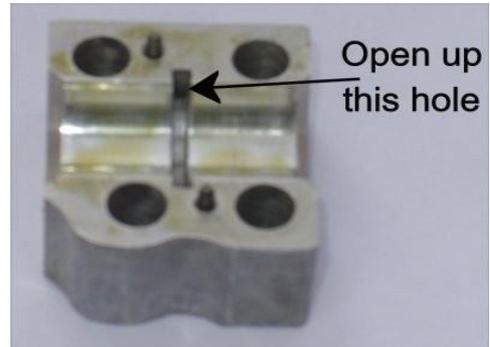
Early models used a 5/16" banjo bolt and these are often over-tightened which distorts the small oil drillings. If this has happened, replace. Now check that the oil ways between the head and the rockers bearings line up. For owners with Samrat rockers fitted, it is worth checking the size of the oil hole through the alloy block. Since 2006 as a matter of course we open up the standard hole to approximately 2.5mm on every set we supply. This allows more flow with lower pressure.
