# Royal Enfield Crusader engine rebuild

by Jack Gray

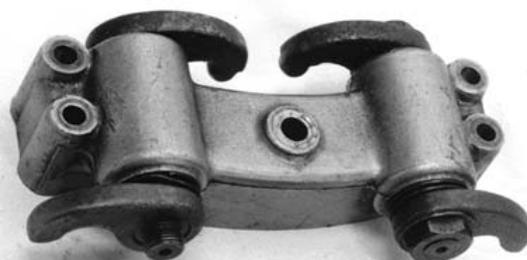
Rockers - late type

From mid-1960, the rocker housing was a one-piece alloy casting fitted with composite rockers and secured by two studs at either end, plus the centre stud for the rocker cover which screws through and helps secure it. The composite rockers, quieter in operation and much longer wearing than the earlier type, have an 11/16" diameter spindle with the arm at each end located by a flat and secured with a nut and washer.

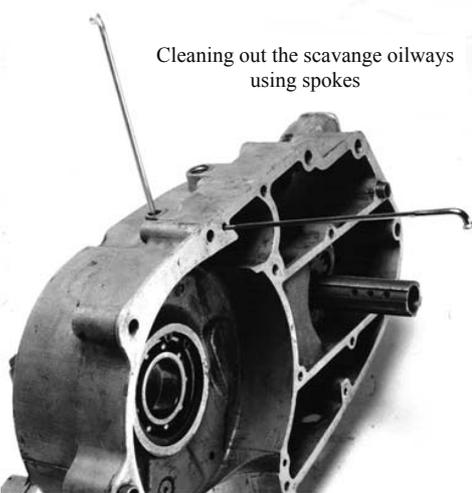
Oil pipes in the timing chest, as described in the text

Pre - 1962 engines were fitted with a hexagon-headed bolt, but if the thread became stripped owners would replace it with a longer bolt which effectively blocked the oilway. From 1963 on this was replaced with a countersunk Allen screw which, being inconspicuous, was seldom removed and therefore gave less bother. When you are satisfied that this section is completely clear, give holes no.6 and 7 the same treatment as 2 and 3; push a rod through hole no.8 (which seldom gives trouble), and check pipes 3 and 4 before bolting the pipe assembly in place.

You may have problems, if the pipes have been distorted, but start with the four-pipe block below the pump and using a new gasket with a thin smear of compound to hold it in place, start both screws in the threaded holes, but do not tighten them.

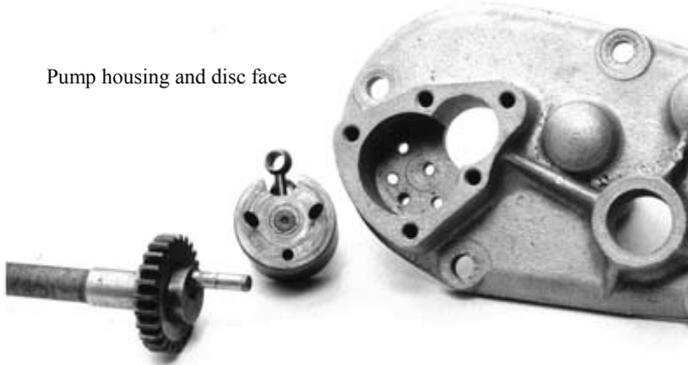
Pump housing and disc face

Another aspect of the pump to consider is the condition of the face of the disc and the housing against which it is kept in close contact by the pressure of the disc spring. A scored disc is easily refaced on a lathe, but remove the very minimum of metal. If it has been refaced before, you may find that the eye of the feed plunger is proud of the face, but this can be ground back. A damaged housing is more difficult to rectify, depending on the equipment available, but if it is badly damaged try to buy a new one if available. If you have access
